**Flood Control Project Maintenance  
Levee Inspections**

**Fall 2011 Levee Maintenance Deficiency Summary Report**

**Tehama County Flood Control and Water Conservation District**

**Levee Inspection Report By Mile - Fall 2011**

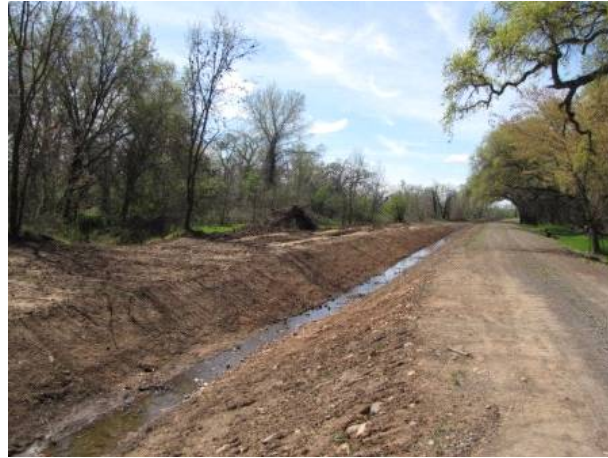
Levee Mile Report Line	1
Start Levee Mile	2.04
End Levee Mile	2.23
Location	Land Side
Category	Earthen Levee
Item	Encroachments
Remove agricultural ditch from toe of levee.	
rduffey_f_20110927_481.jpg

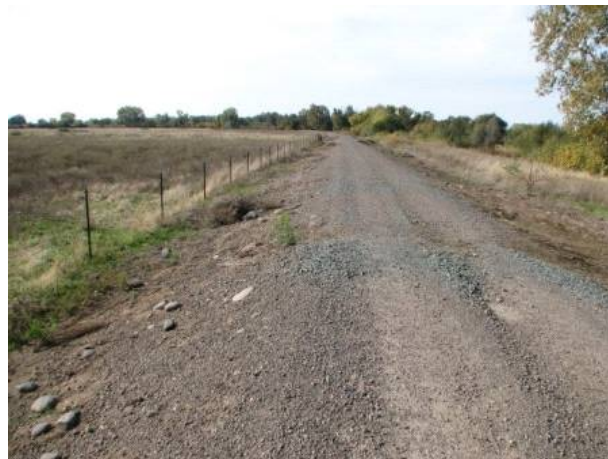
Levee Mile Report Line	3
Start Levee Mile	2.72
End Levee Mile	2.76
Location	Crown
Category	Earthen Levee
Item	Slope Stability
Erosion on crown and both slopes.	
rduffey_f_20110927_482.jpg

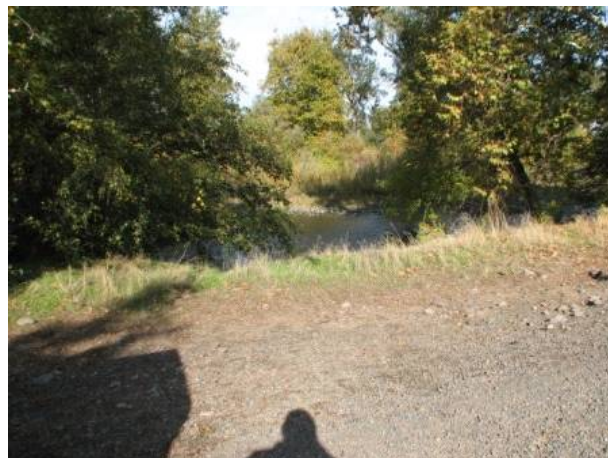
Levee Mile Report Line	4
Start Levee Mile	2.79
End Levee Mile	2.79
Location	Water Side
Category	Earthen Levee
Item	Erosion / Bank Caving
Erosion along the channel.	
rduffey_f_20110927_485.jpg

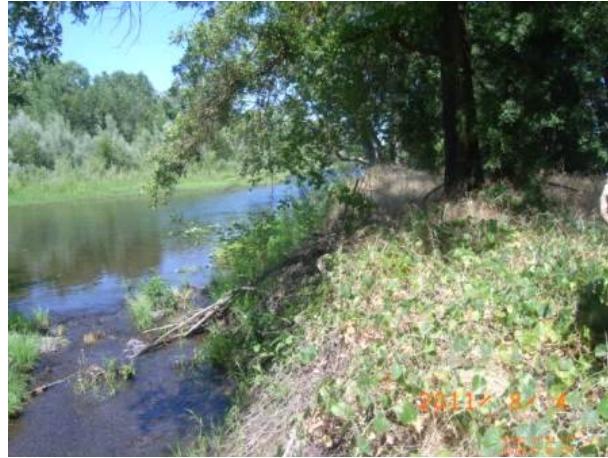
USACE 2011 Photo #1

Levee Mile Report Line	5
Start Levee Mile	2.98
End Levee Mile	3.00
Location	Water Side
Category	Supplemental
Item	USACE Erosion Survey

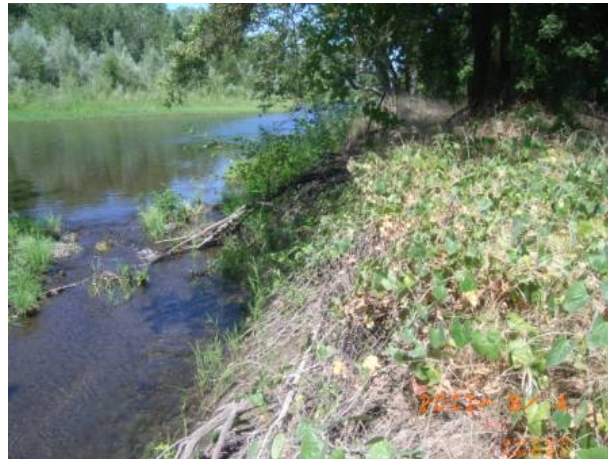
USACE 2011 Photo #2

Levee Mile Report Line	5
Start Levee Mile	2.98
End Levee Mile	3.00
Location	Water Side
Category	Supplemental
Item	USACE Erosion Survey

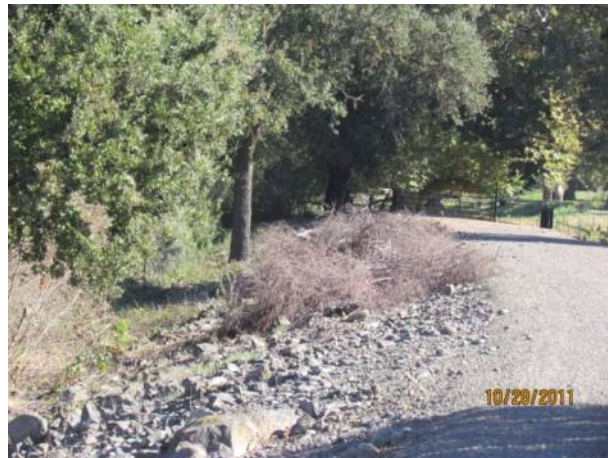
Levee Mile Report Line	6
Start Levee Mile	3.29
End Levee Mile	3.38
Location	Water Side
Category	Earthen Levee
Item	Encroachments

View of prunings along the W/S slope.

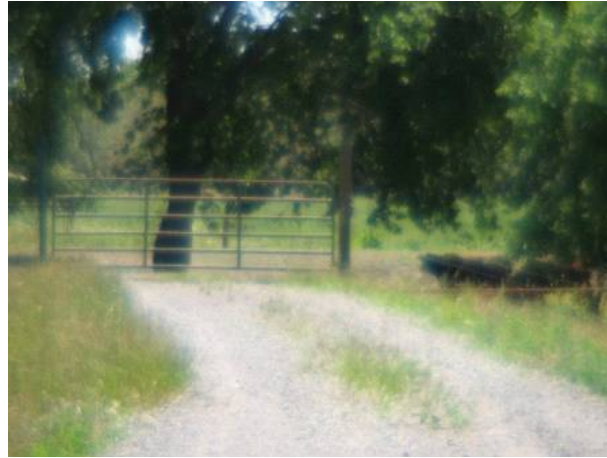
Levee Mile Report Line	7
Start Levee Mile	3.64
End Levee Mile	3.64
Location	Crown
Category	Earthen Levee
Item	Encroachments

View of the non-permitted gate on the crown of the levee.

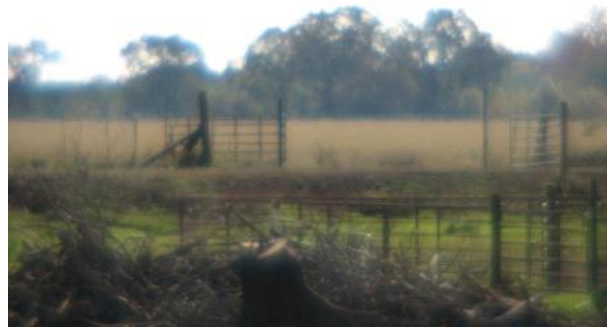
Levee Mile Report Line	8
Start Levee Mile	3.74
End Levee Mile	3.74
Location	Crown
Category	Earthen Levee
Item	Encroachments

View of the non-permitted gate on the crown roadway.

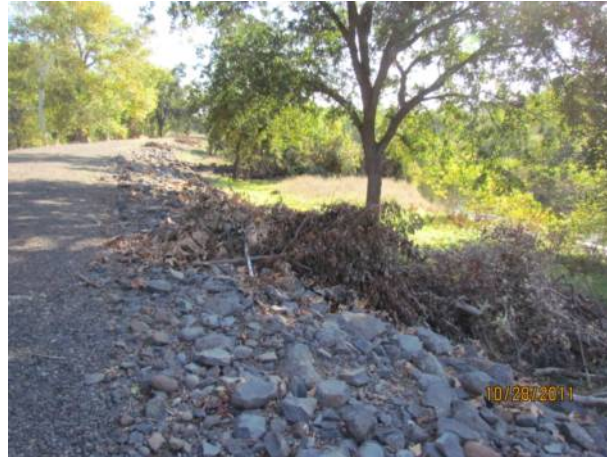
Levee Mile Report Line	1
Start Levee Mile	0.25
End Levee Mile	0.25
Location	Water Side
Category	Earthen Levee
Item	Encroachments

View of the prunings along the W/S slope.

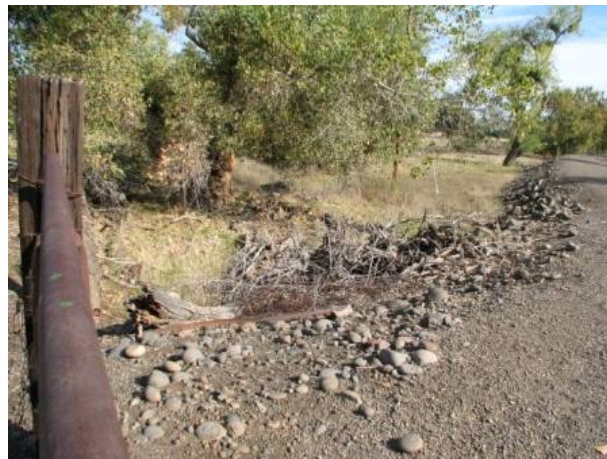
Levee Mile Report Line	2
Start Levee Mile	0.31
End Levee Mile	0.31
Location	Land Side
Category	Earthen Levee
Item	Encroachments

View of debris & wire at toe of levee.

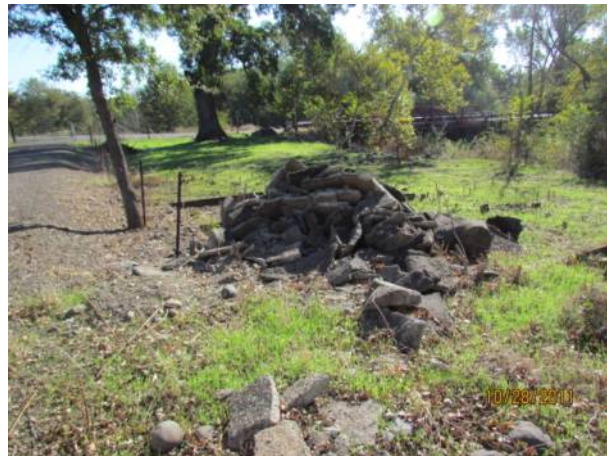
Levee Mile Report Line	3
Start Levee Mile	0.34
End Levee Mile	0.34
Location	Water Side
Category	Earthen Levee
Item	Encroachments

View of the concrete pile along the W/S toe.

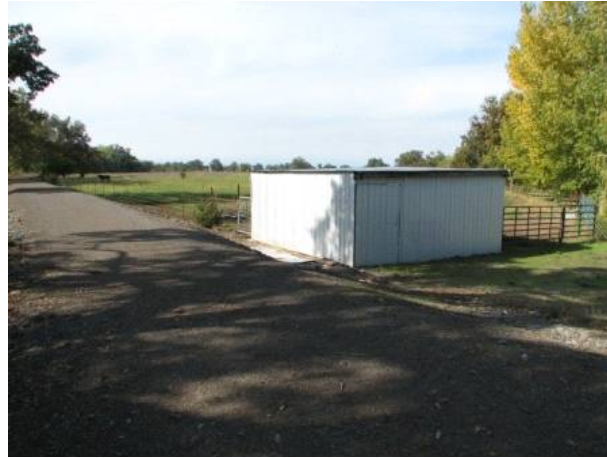
Levee Mile Report Line	4
Start Levee Mile	0.36
End Levee Mile	0.36
Location	Land Side
Category	Earthen Levee
Item	Encroachments

View of building at toe of levee.

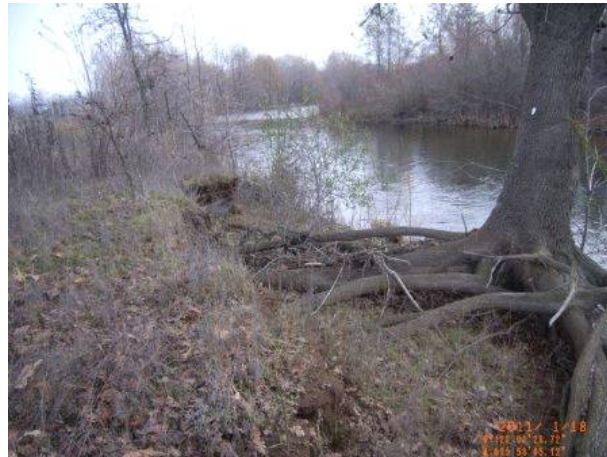
USACE 2011 Photo #1

Levee Mile Report Line	5
Start Levee Mile	0.76
End Levee Mile	0.91
Location	Water Side
Category	Supplemental
Item	USACE Erosion Survey

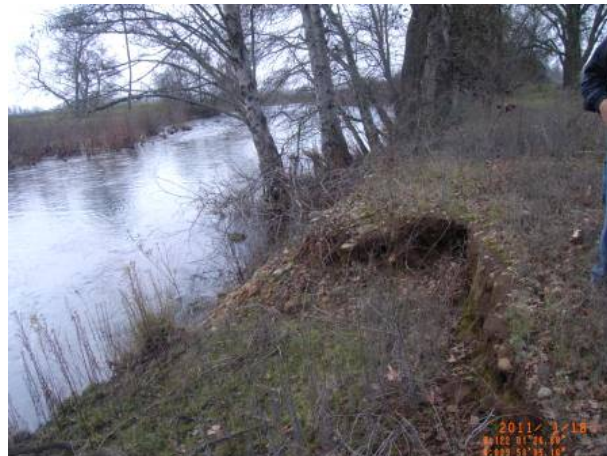
USACE 2011 Photo #2

Levee Mile Report Line	5
Start Levee Mile	0.76
End Levee Mile	0.91
Location	Water Side
Category	Supplemental
Item	USACE Erosion Survey

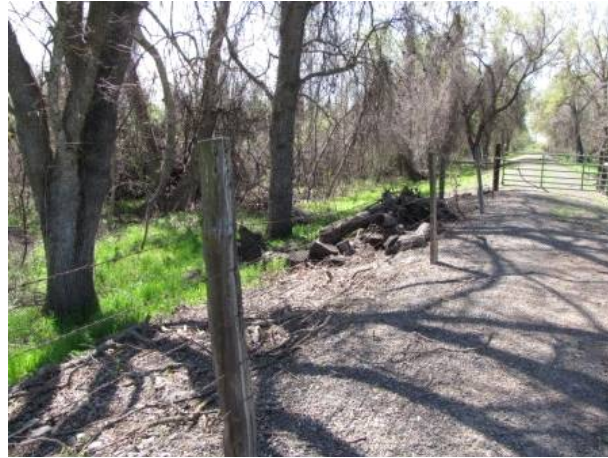
Levee Mile Report Line	6
Start Levee Mile	1.30
End Levee Mile	1.30
Location	Water Side
Category	Earthen Levee
Item	Encroachments
Remove all fire wood.	
rduffey_f_20110927_487.jpg

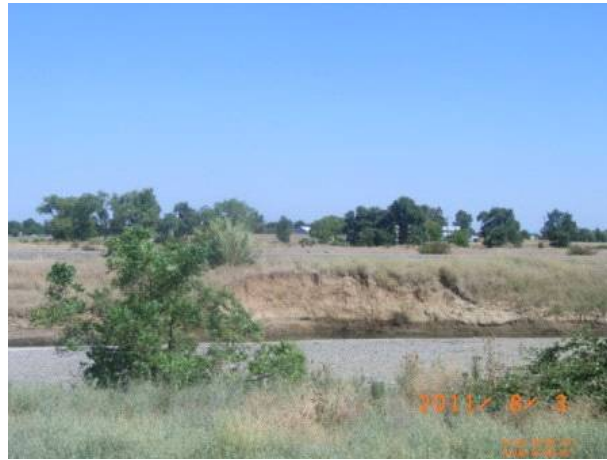
USACE 2011 Photo #1

LMR No.	Levee Mile		Category	Item	Location *	Rating **	Action/Comment	GPS Latitude/Longitude		Issue No.
	Start	End						Start	End	
1	1.38	1.51	Supplemental	USACE Erosion Survey	WS	M	Inspector Comments: 2006 - High vertical bank due to mass failures. Thalweg meandering and erosion of bank. Banks are cohesive with non-cohesive gravel horizons. 2011: Foundation is silty-sand with gravel. New slumping at the toe, mass failure continues. [2011 Site ID: ELC_1-4_L]	40.051596 ° -122.164179 °	40.051979 ° -122.163106 °	9 Y
2	1.60	1.71	Earthen Levee	Slope Stability	WS	M	Repair the levee slope damaged by vehicle traffic and prevent access where possible.	40.052607 ° -122.161418 °	40.053558 ° -122.159903 °	3 Y
3	2.00	2.22	Earthen Levee	Crown Surface / Depressions / Rutting	CR	M	Regrade the crown roadway for proper drainage.	40.052610 ° -122.154793 °	40.051990 ° -122.150867 °	8 Y
4	2.32	2.32	Earthen Levee	Slope Stability	LS	M	Repair the levee slope damaged by vehicle traffic and prevent access where possible.	40.052415 ° -122.149208 °	40.052415 ° -122.149208 °	18 Y

Levee Mile Report Line	1
Start Levee Mile	1.38
End Levee Mile	1.51
Location	Water Side
Category	Supplemental
Item	USACE Erosion Survey

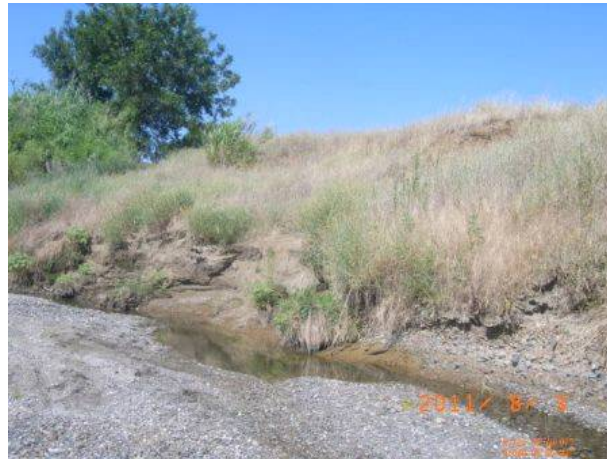
USACE 2011 Photo #2

Levee Mile Report Line	1
Start Levee Mile	1.38
End Levee Mile	1.51
Location	Water Side
Category	Supplemental
Item	USACE Erosion Survey

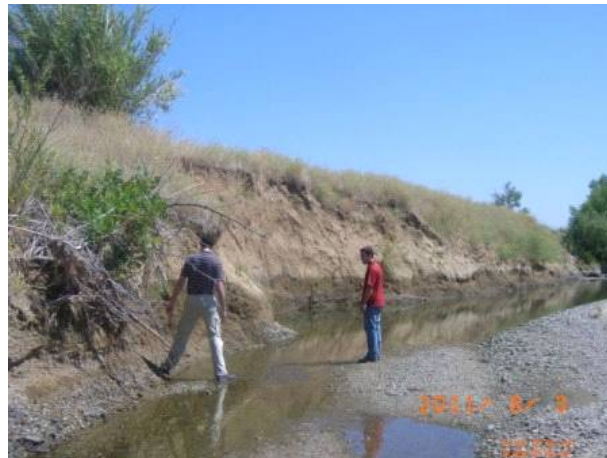
USACE 2011 Photo #3

Levee Mile Report Line	1
Start Levee Mile	1.38
End Levee Mile	1.51
Location	Water Side
Category	Supplemental
Item	USACE Erosion Survey

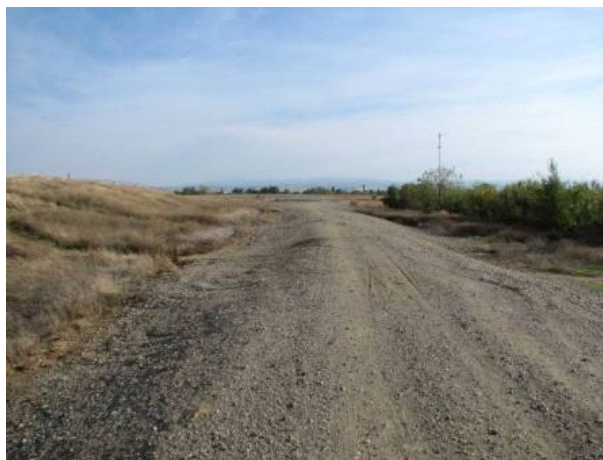
Levee Mile Report Line	2
Start Levee Mile	1.60
End Levee Mile	1.71
Location	Water Side
Category	Earthen Levee
Item	Slope Stability

View of vehicle erosion on the crown & both slopes.

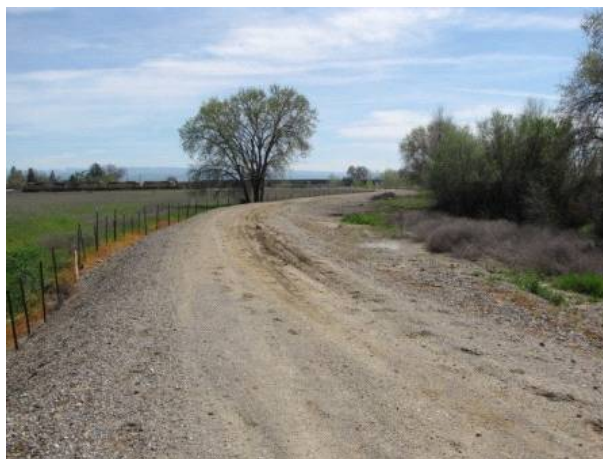
Levee Mile Report Line	3
Start Levee Mile	2.00
End Levee Mile	2.22
Location	Crown
Category	Earthen Levee
Item	Crown Surface / Depressions / Rutting

View of the crown roadway that needs gravel & grading.

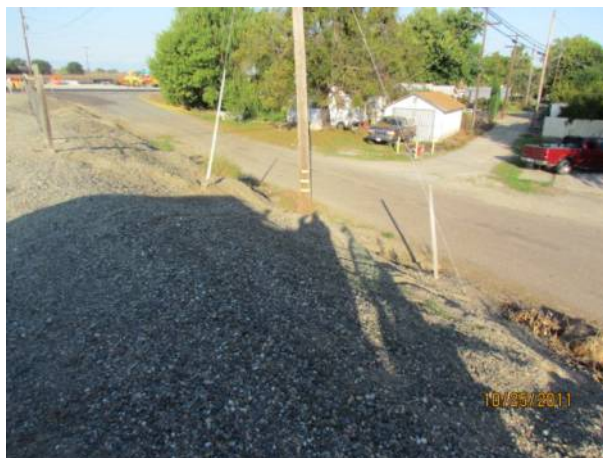
Levee Mile Report Line	4
Start Levee Mile	2.32
End Levee Mile	2.32
Location	Land Side
Category	Earthen Levee
Item	Slope Stability

View of the vehicle erosion along the L/S slope.

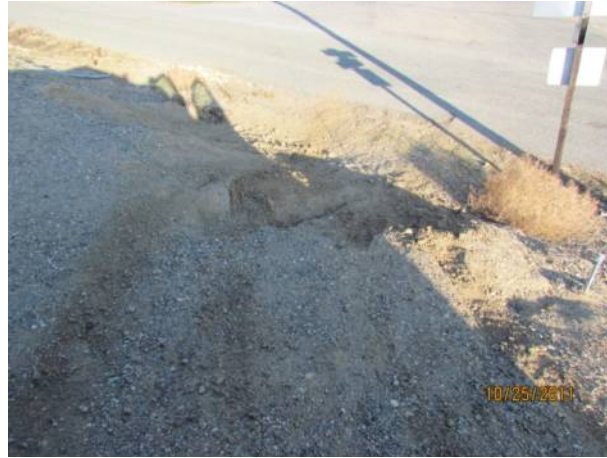
View of the vehicle erosion along the L/S slope.

5	2.46	2.46	Earthen Levee	Slope Stability	LS	M	Repair the levee slope damaged by vehicle traffic and prevent access where possible.	40.052417 ° -122.146747 °	40.052417 ° -122.146747 °	20 Y
6	2.53	2.53	Earthen Levee	Slope Stability	LS	M	Repair the levee slope damaged by vehicle traffic and prevent access where possible.	40.052872 ° -122.145495 °	40.052872 ° -122.145495 °	2 Y
7	2.66	2.66	Earthen Levee	Encroachments	LS	M	Debris	40.054352 ° -122.144245 °	40.054352 ° -122.144245 °	4 Y
8	2.82	2.85	Earthen Levee	Slope Stability	LS	M	Repair the levee slope damaged by vehicle traffic and prevent access where possible.	40.055033 ° -122.141457 °	40.055595 ° -122.141203 °	916 Y
9	3.02	3.02	Earthen Levee	Animal Control	LS	M	No rodents visible, but rodent burrows visible; need to backfill and compact or grout burrows.	40.056514 ° -122.139449 °	40.056514 ° -122.139449 °	5 Y
10	3.03	3.03	Earthen Levee	Slope Stability	WS	M	Repair the levee slope damaged by vehicle traffic and prevent access where possible.	40.056388 ° -122.139168 °	40.056388 ° -122.139168 °	10 Y

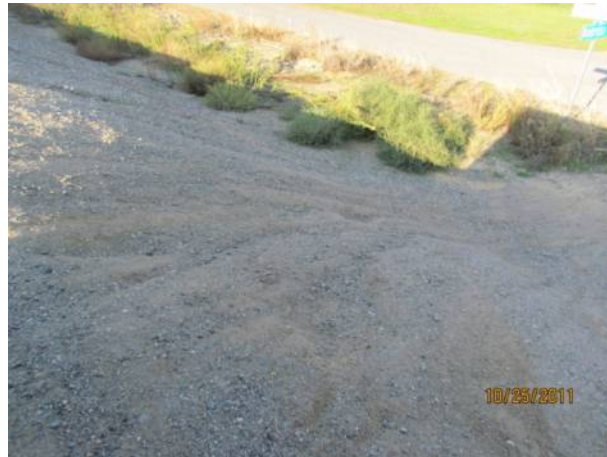
Levee Mile Report Line	6
Start Levee Mile	2.53
End Levee Mile	2.53
Location	Land Side
Category	Earthen Levee
Item	Slope Stability

View of the vehicle erosion along the L/S slope.

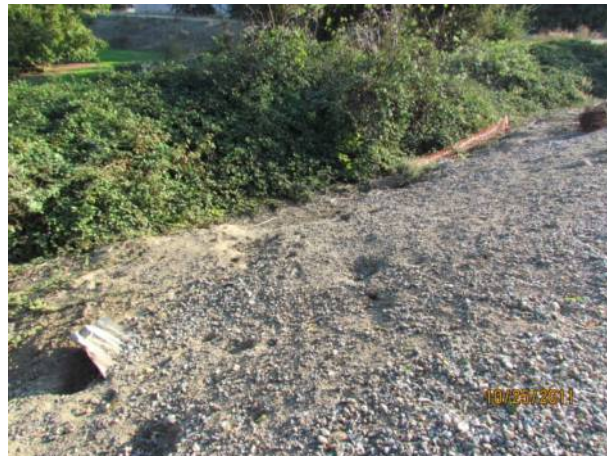
Levee Mile Report Line	9
Start Levee Mile	3.02
End Levee Mile	3.02
Location	Land Side
Category	Earthen Levee
Item	Animal Control

View of the rodent holes along the L/S slope.

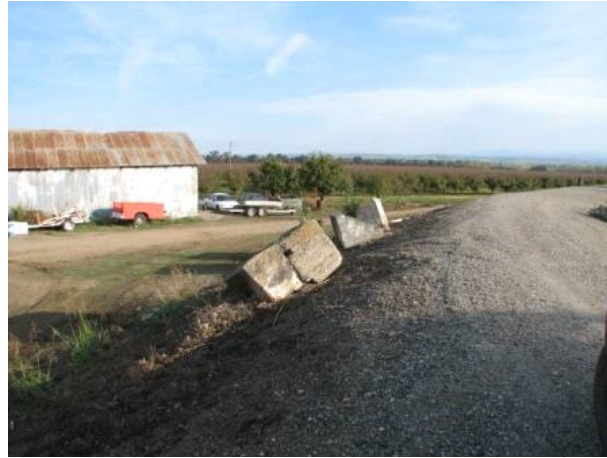
View of the concrete stairways on the slope.

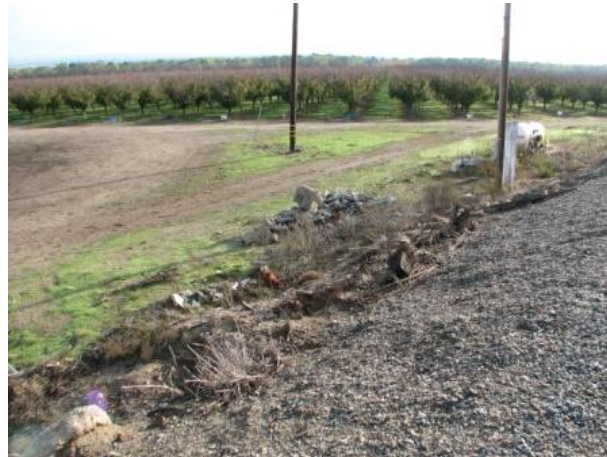
Levee Mile Report Line	12
Start Levee Mile	3.34
End Levee Mile	3.34
Location	Land Side
Category	Earthen Levee
Item	Encroachments

View of the garbage and metal at the toe of the levee & along the slope of the landside.

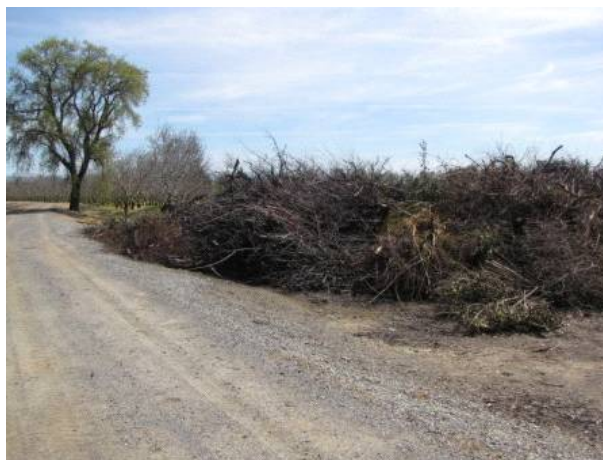
View of the debris & pruning pile brush next to the toe.

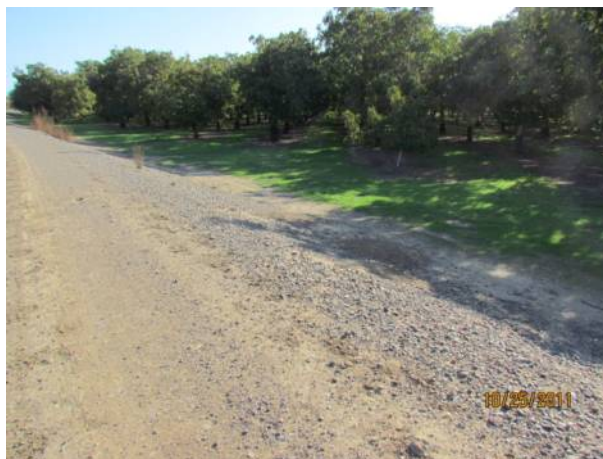
Levee Mile Report Line	2
Start Levee Mile	0.96
End Levee Mile	0.96
Location	Land Side
Category	Earthen Levee
Item	Animal Control

View of the rodent holes along the L/S slope.

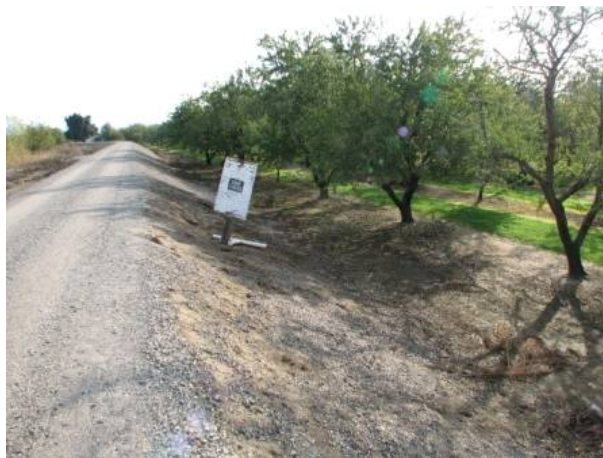
Levee Mile Report Line	3
Start Levee Mile	2.57
End Levee Mile	2.57
Location	Land Side
Category	Earthen Levee
Item	Animal Control

View of the bait station next to the squirrel holes on the landside slope.

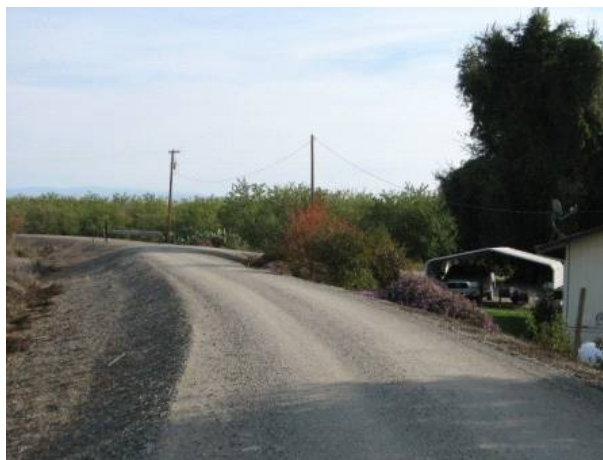
View of the landscape along the slope.

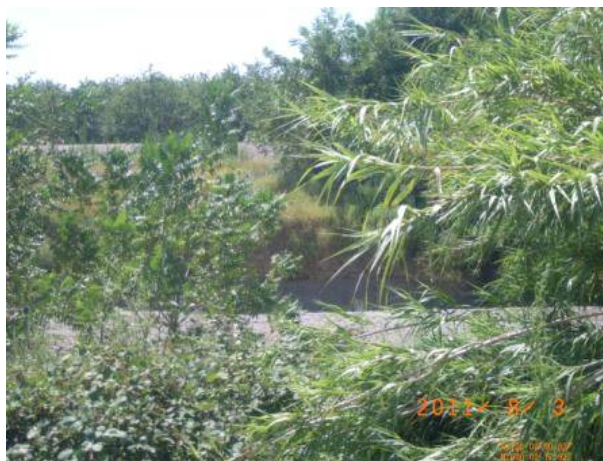
USACE 2011 Photo #1

Levee Mile Report Line	5
Start Levee Mile	2.98
End Levee Mile	3.00
Location	Water Side
Category	Supplemental
Item	USACE Erosion Survey

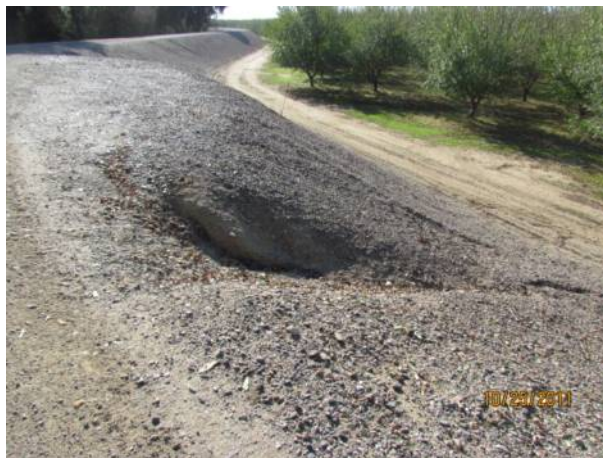
Levee Mile Report Line	8
Start Levee Mile	3.45
End Levee Mile	3.45
Location	Land Side
Category	Earthen Levee
Item	Erosion / Bank Caving

View of the erosion along the L/S slope.
